#### Ratio Testing Transformers under Construction

## **TTRU3 Application Note**

## **Factory Ratio Testing of Power Transformer**

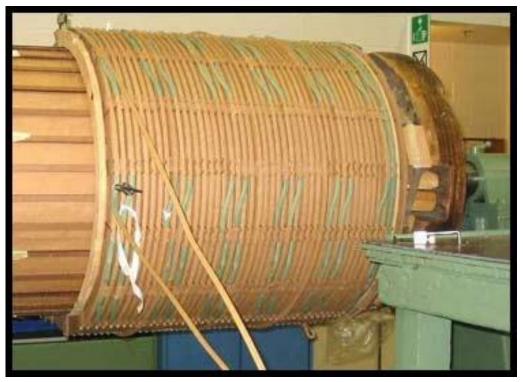
Winding stack under construction re used: Art Mandigo Winding Service

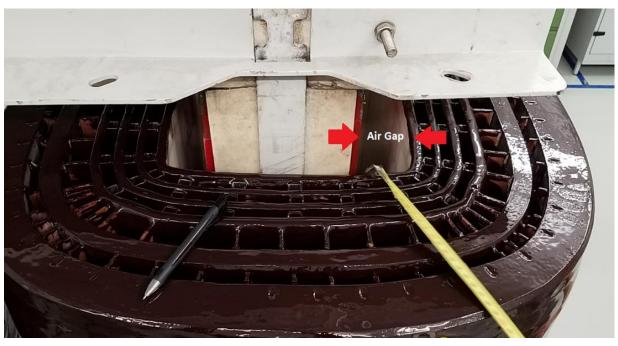
#### Universal test core with a large air gap

Reduces magnetic coupling, resulting in higher flux leakage - increased ratio error

When an individual winding stack is built, it is often tested on a universal test core prior to placing the winding stacks on the final core. The ratio measurements during this testing validate proper winding turns. The universal test core is critical for preliminary ratio testing of a winding during construction, but it produces ratio errors due to

- 1) reluctance in the flux path at the butt joint
- 2) a wide air gap between the universal test core and the winding

With poor coupling and high magnetic reluctance, the ability to measure ratio within the required +/-0.5% of nameplate ratio becomes difficult and is not reflective of the final ratio measurements.

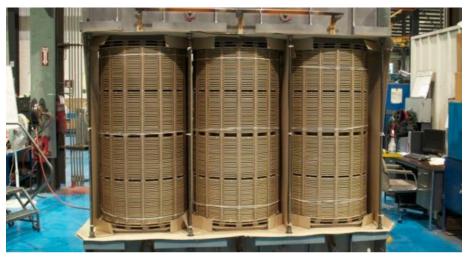
Three-Phase winding assembled with the final core Picture from LinkedIn – Manuel Bolotinha – Dec 2017

Once a core and windings are assembled a series of tests are conducted to ensure the transformer is mechanically sound and built to specifications. Whether large or small, most transformers undergo this testing prior to solid epoxy or liquid insulation application. This is done so that time and material costs are not put at jeopardy. This is the last opportunity to correct issues, and testing accuracy is critical to ensure that specifications are met.
